Tour Days 13-14

Yujian Railway (former ChaoQi Line)

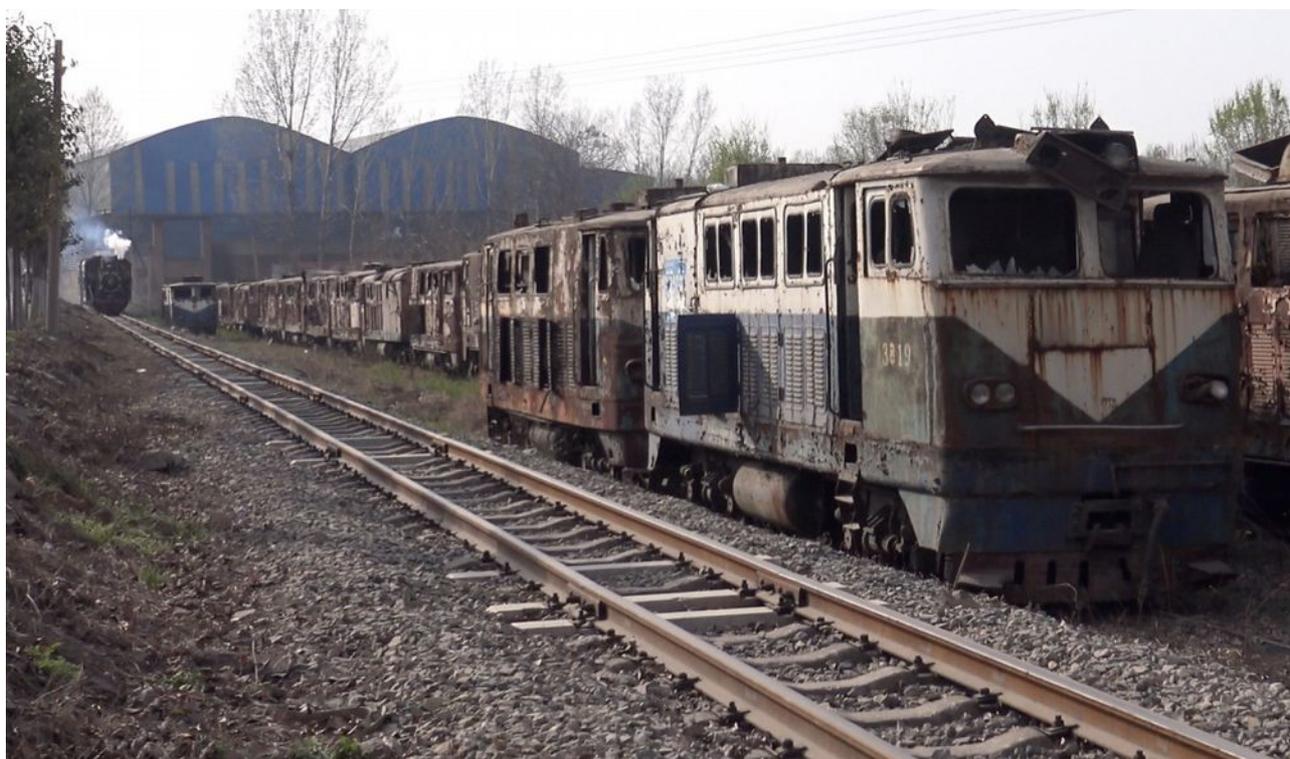
The general Chaoyanggou station shots appear under Day 14 below. The first shots from Day 13 are of the train hauled by C2 007 passing the 19 dumped CMY380 locos collected from several local narrow gauge lines that have closed. Their fate is unclear but they were probably not collected together in this remote location around 6km from Chaoyanggou to be scrapped.

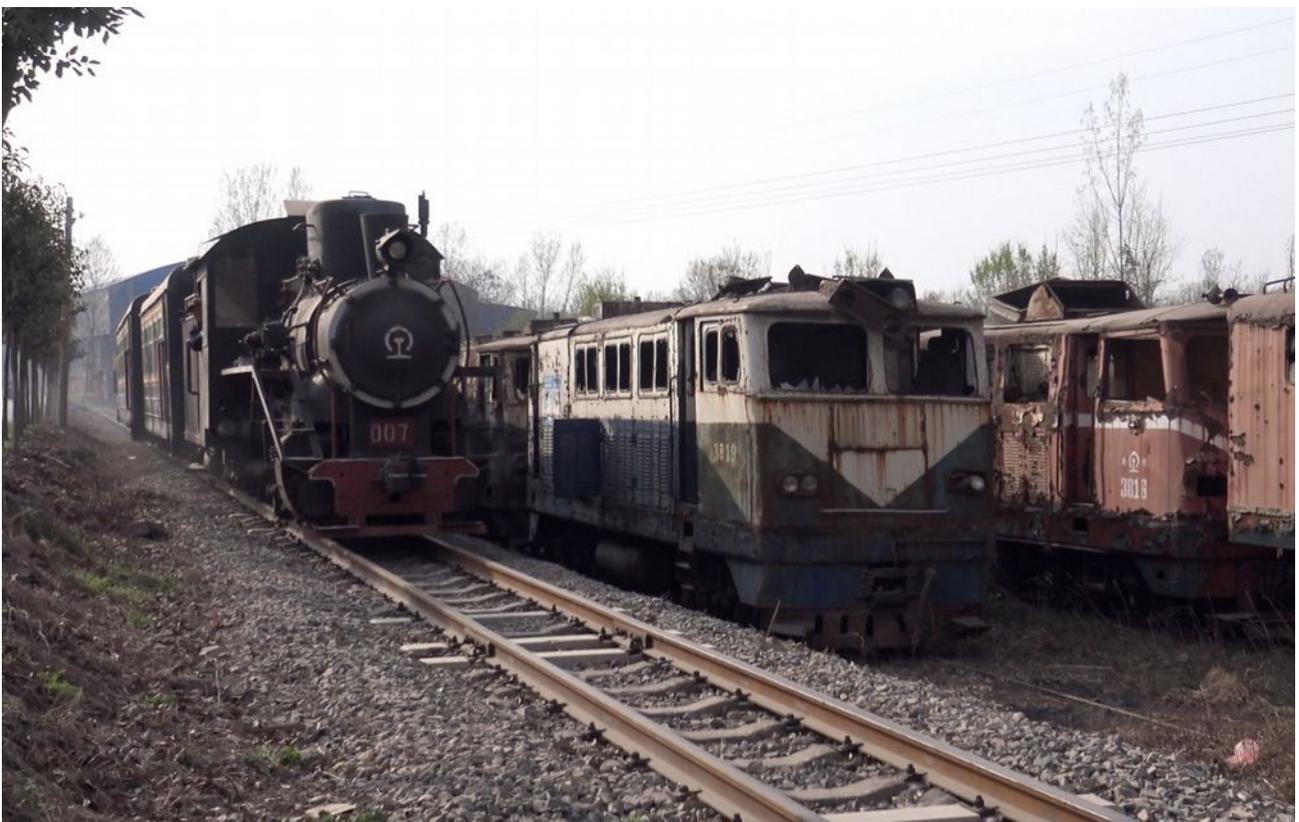
Unfortunately, 007 and other C2s here have been adapted with noisy diesel generators in the tender. One of the purposes for this is to feed water into the boiler in place of the original steam injectors.

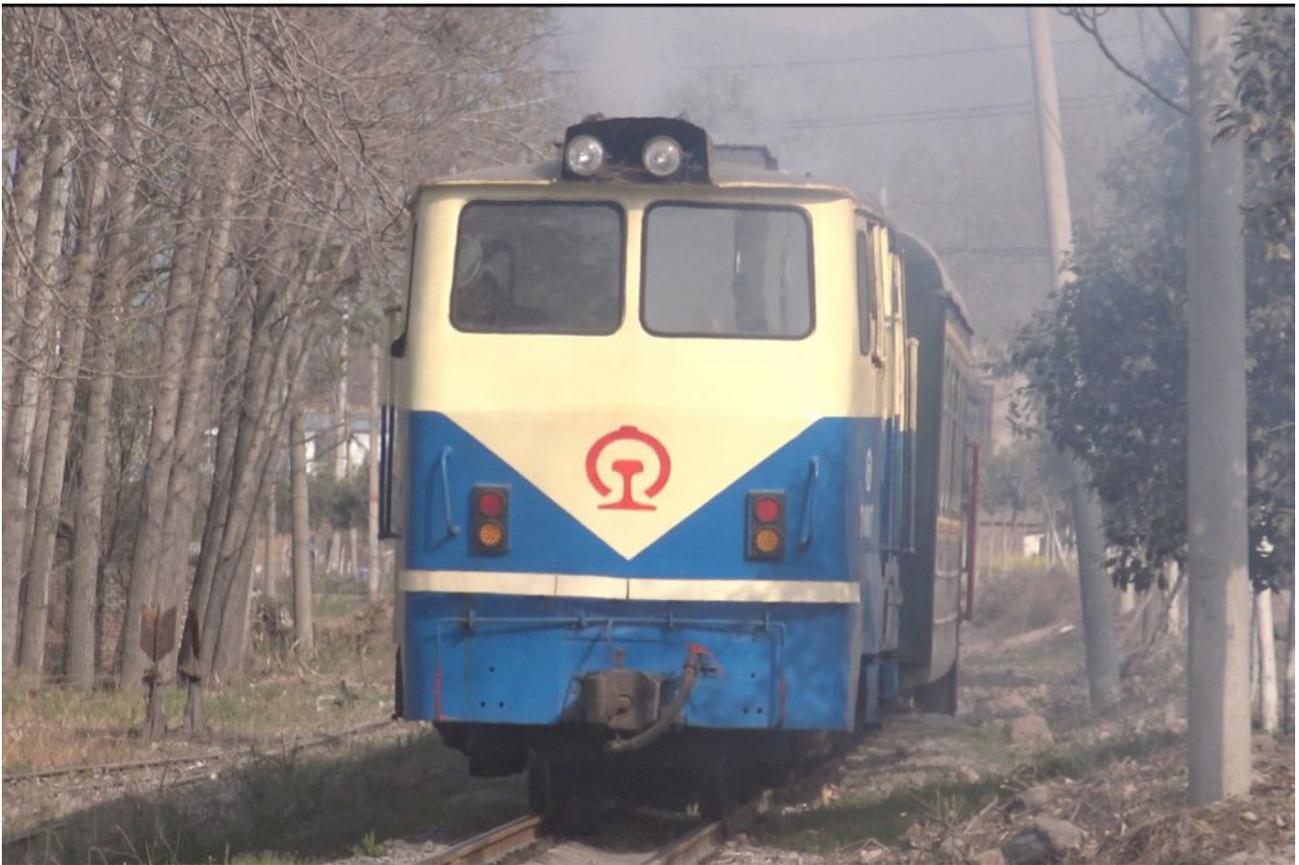
Diesel 3807 on the rear of the train will haul the train back from Chaohua.

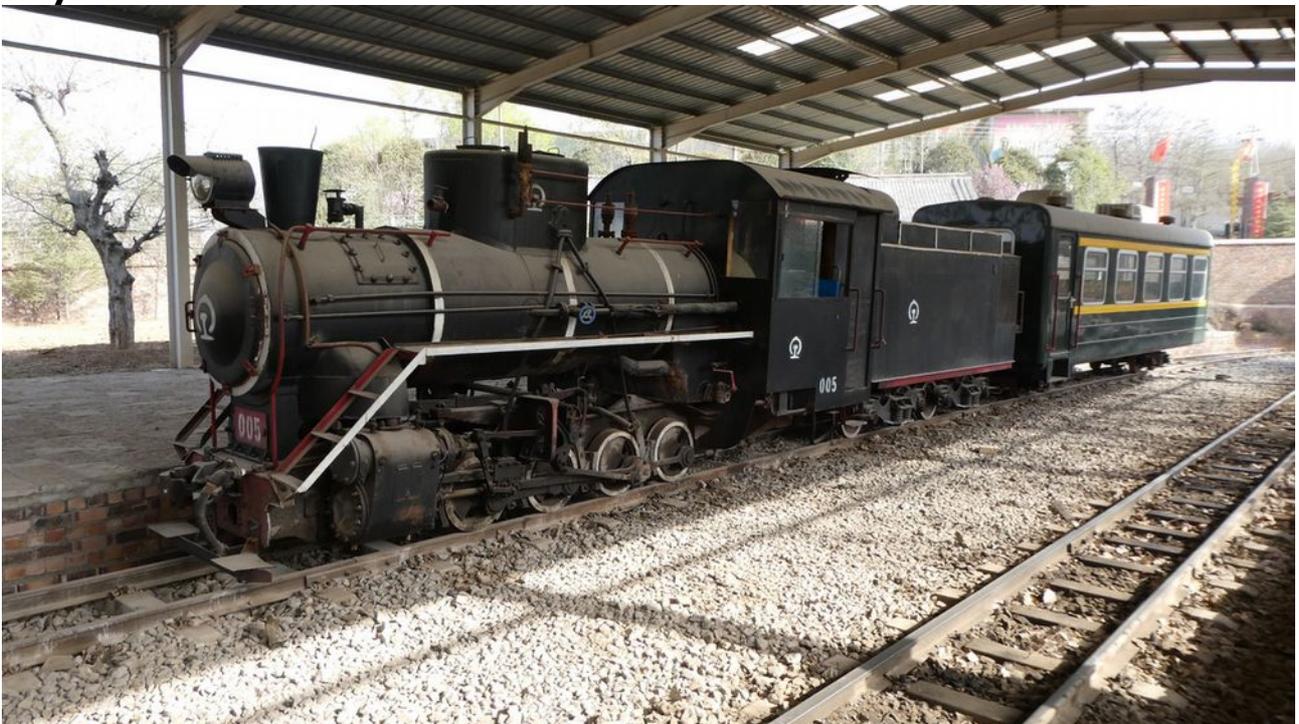
C2 005 with a single coach at platform 2 at Chaoyanggou. It displays some changes including a new low chimney, altered smokebox door, various new bits of steel plate and water feed pumps instead of injectors.

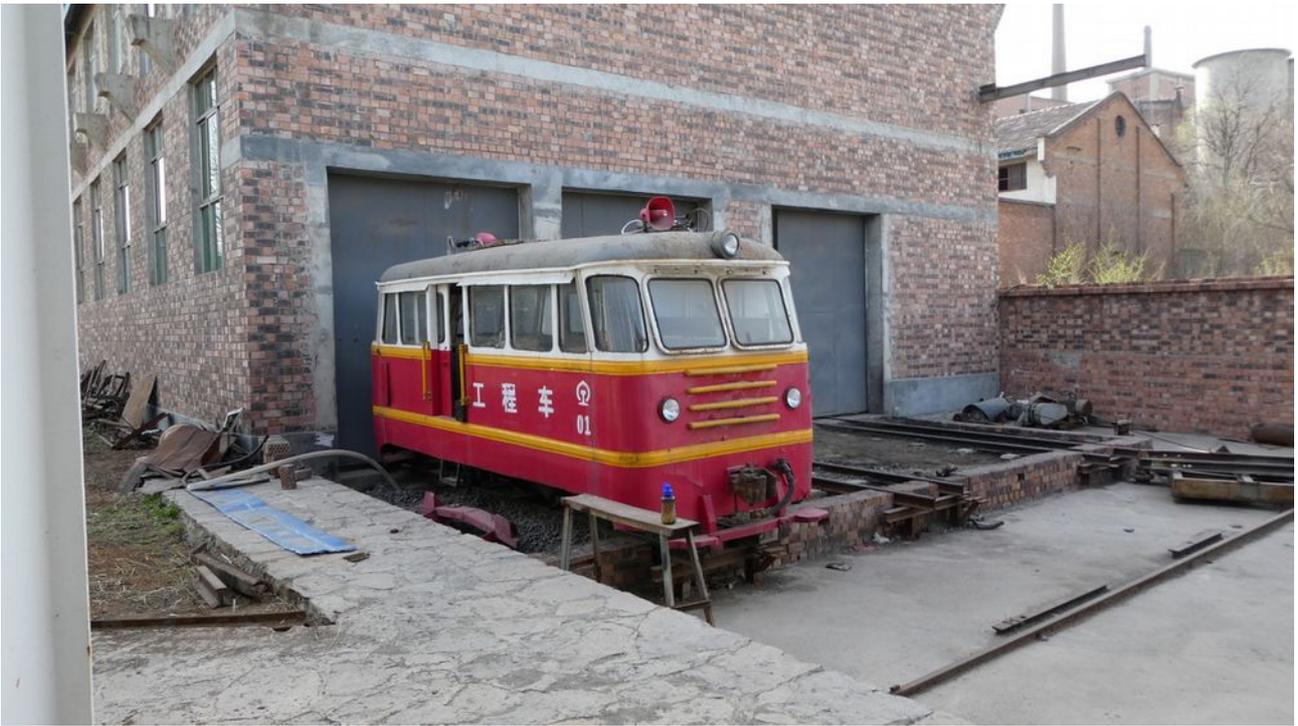
A Permanent Way Railbus at the depot.

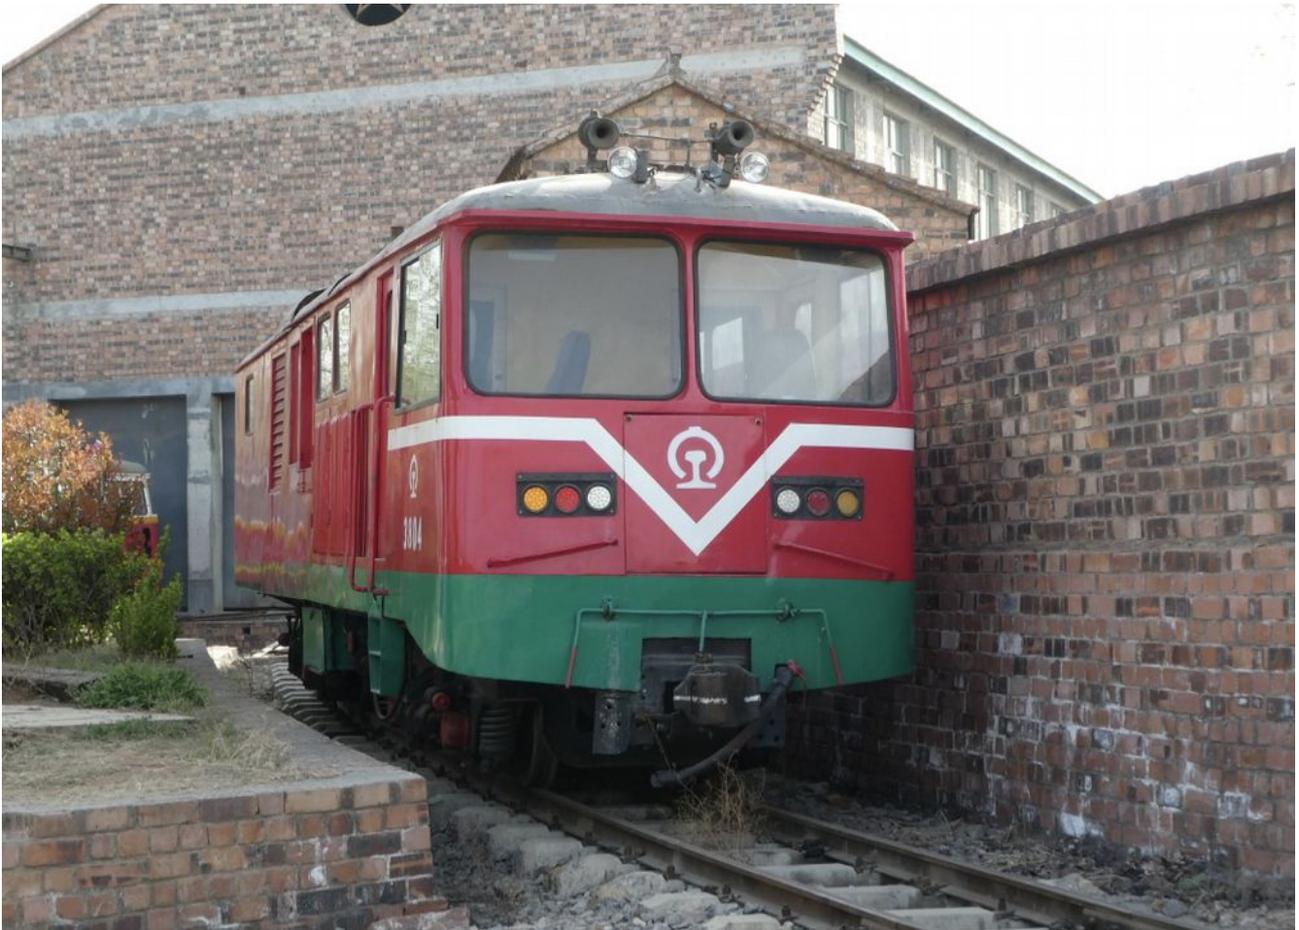
JMY380 3804 at the depot has a cab at one end only.

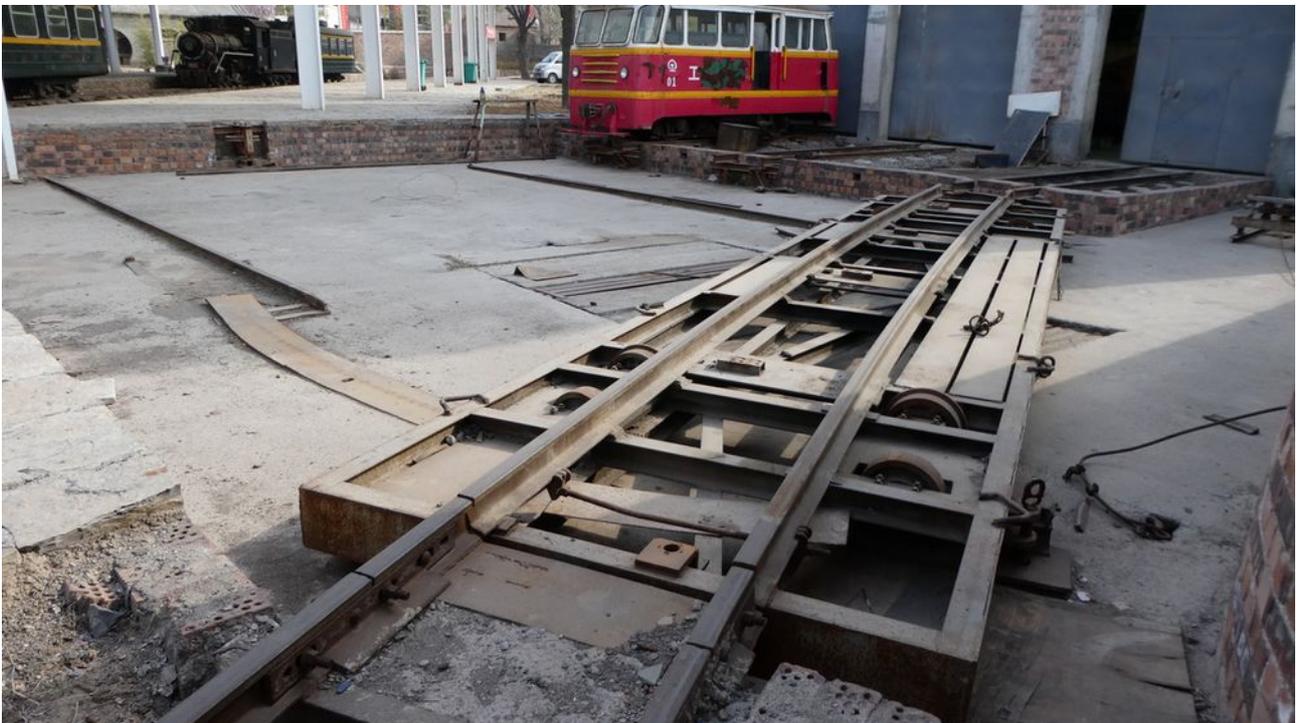
The over-engineered swivelling traverser at the depot. In order to enter the depot, the loco must be positioned on the traverser, the traverser swung left and then to access the second and third roads, the traverser needs to slide sideways. Both rollers and wheels with flanges are needed as well as a cable to pull the traverser from either side. A simpler solution would have been to build

the new shed somewhere else or on a different alignment.

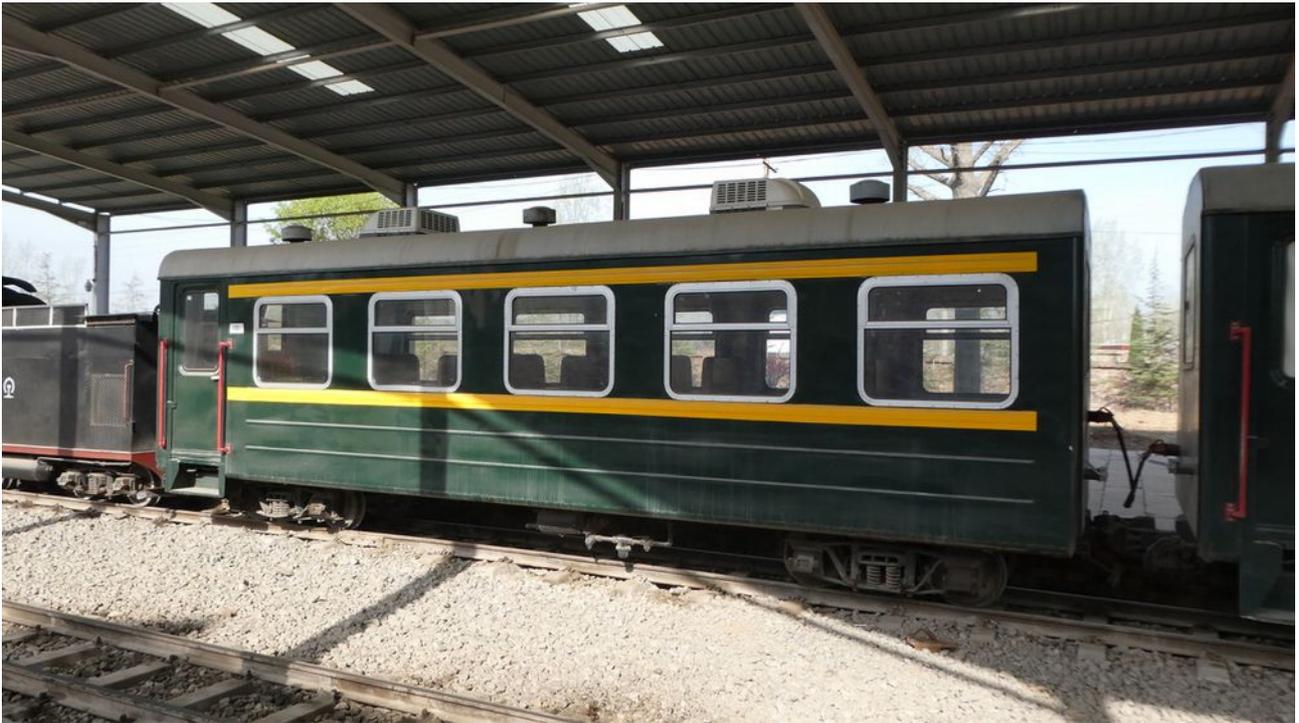
Short bodied coaches with doors at one end only are used.

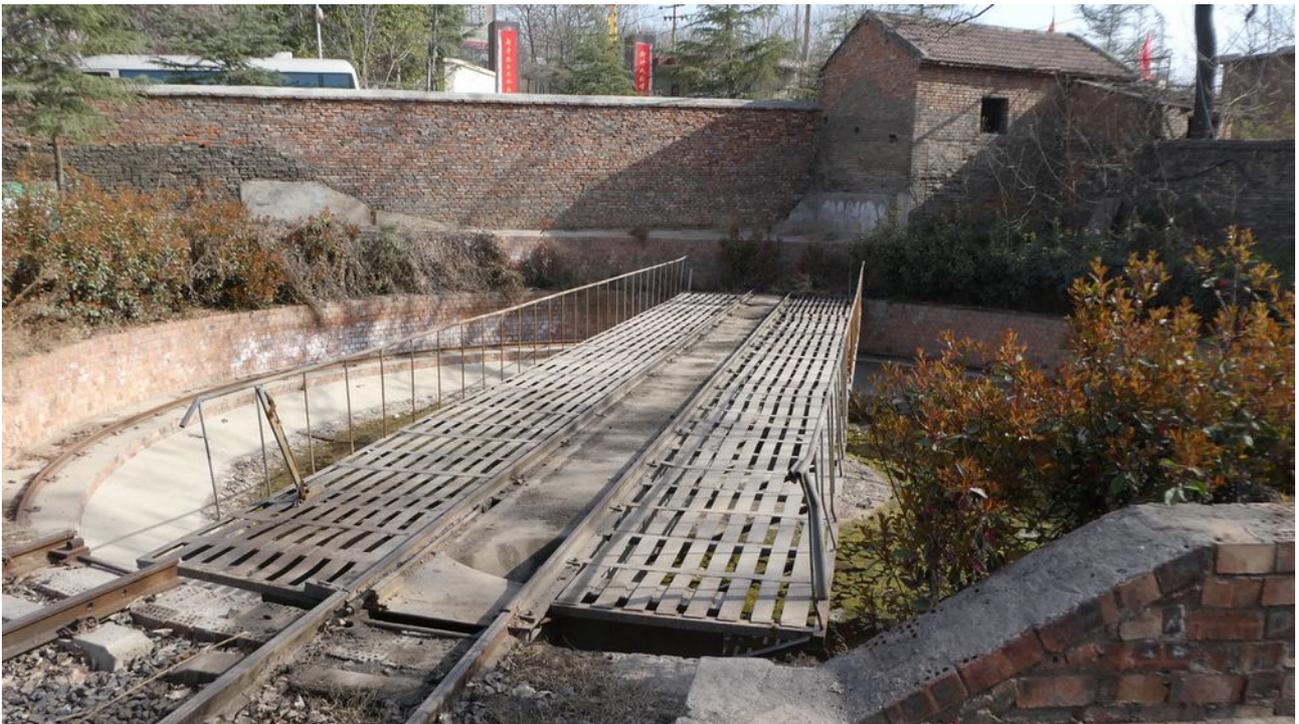
The turntable at the end of the station is most likely from the steam era. It's not clear if it has been repositioned from somewhere else.

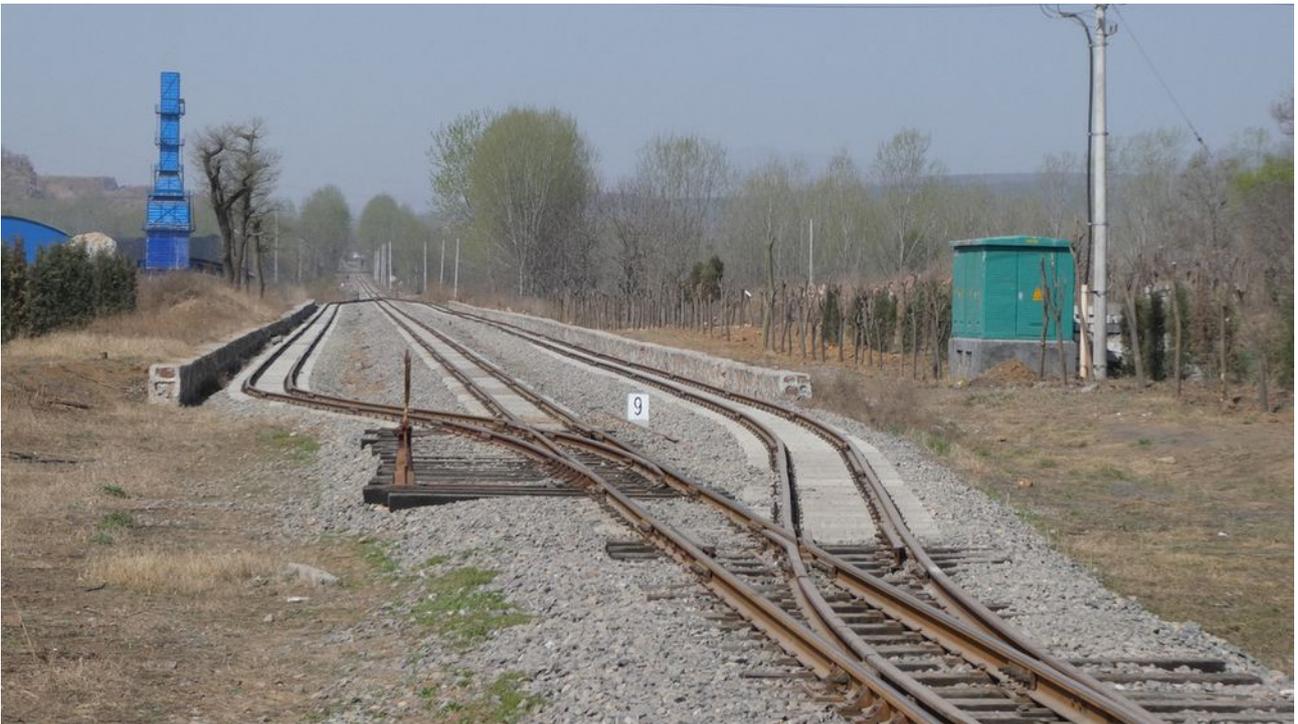
At one of the intermediate stations, the quality of the renewed trackwork is impressive with 2 platform roads and a through road but will it ever be fully used?

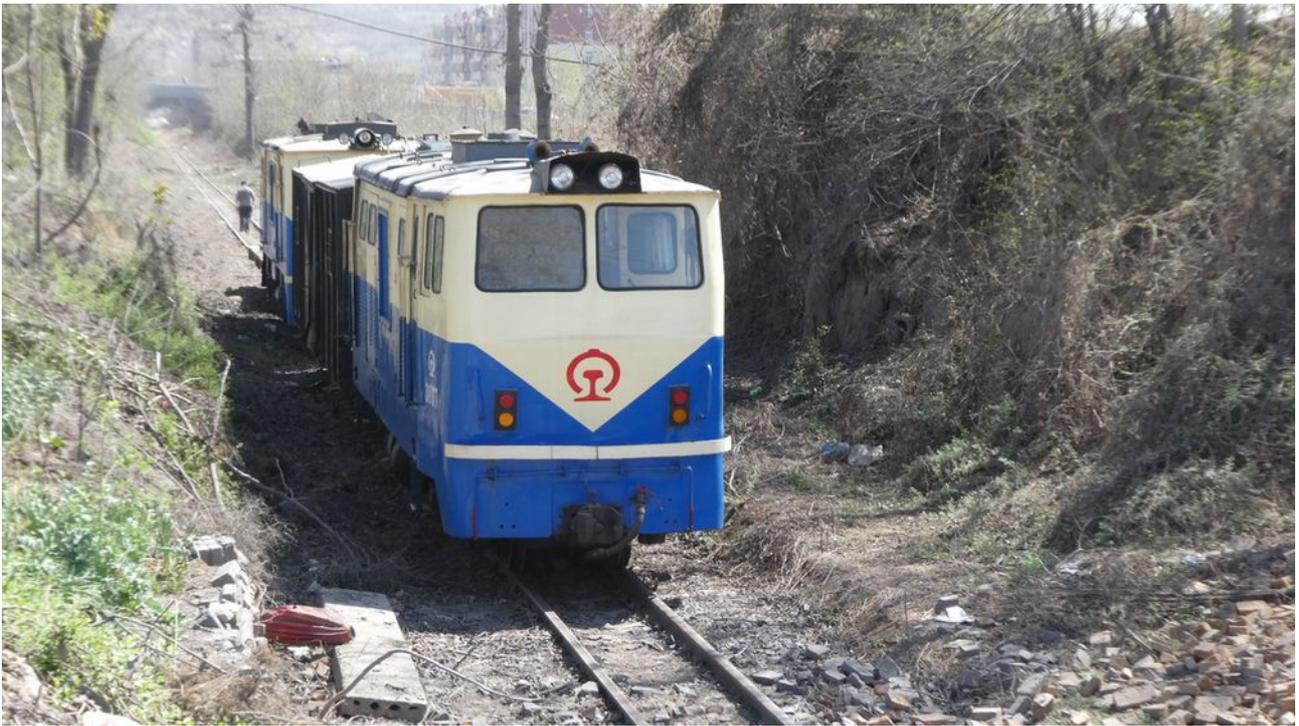
We found 3807 and 3801 with a box van and a flat wagon on permanent way duties near Pingmo. This was as far as we got exploring the line to Chaohua.

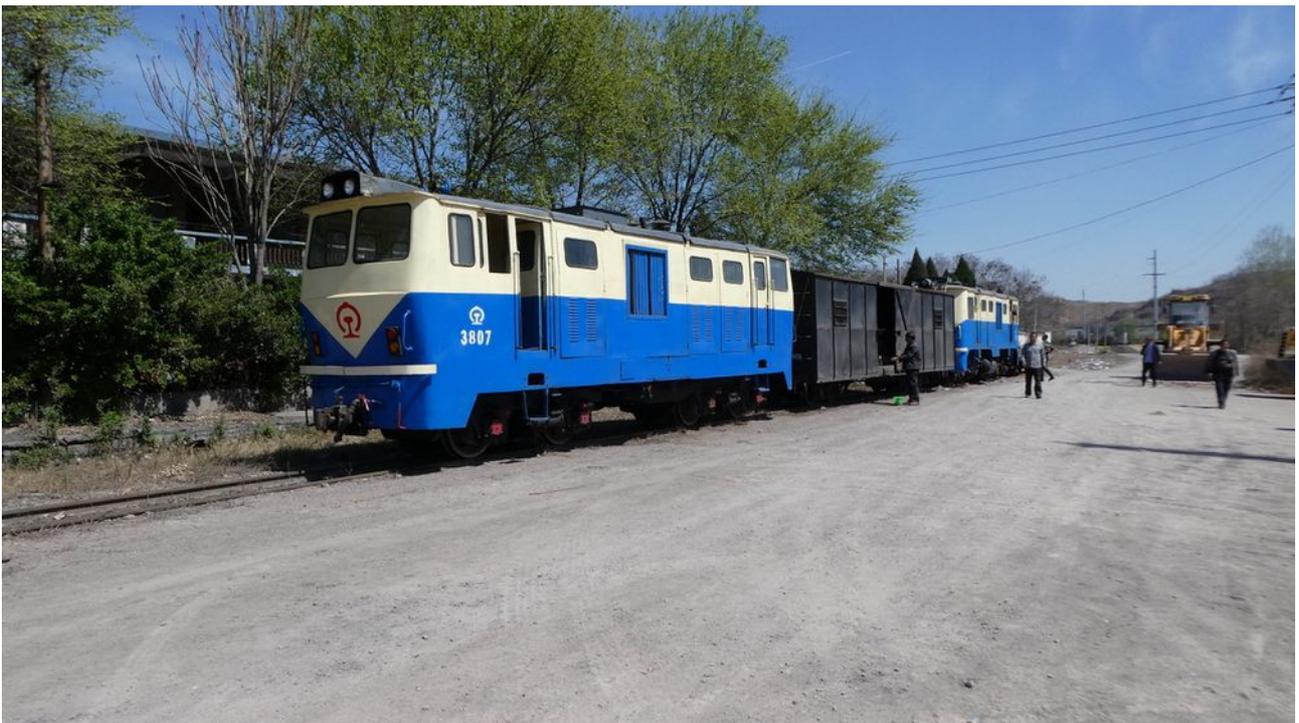
The train is stabled at Pingmo while the crew prepare lunch in the box car. The loco closest to us appears to be double ended but can only be driven from this end. The rear loco has no window at the back (towards us) so appears single ended and can be driven from the far end only.
